Re: Inspection Report #9: 9 October through 12 October 2007,

Former Raytheon Facility 430 Boston Post Road DEP File No. 322-647

INSPECTION REPORT #9

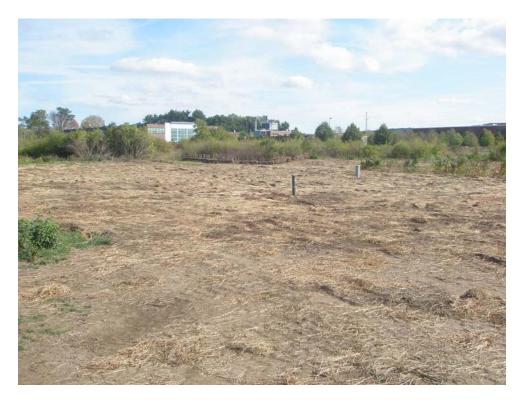
Photograph 1 – Project Area from Northwest after Seeding and Mulching

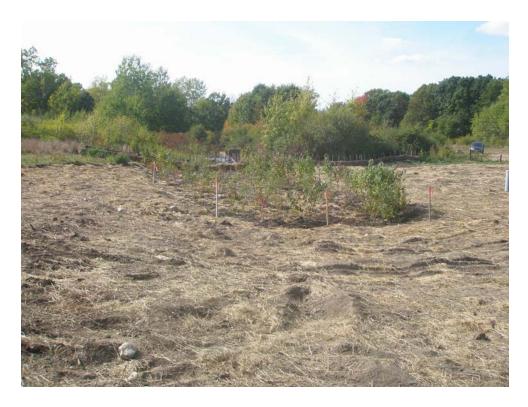
Photograph 2 – Restored Wetland from East

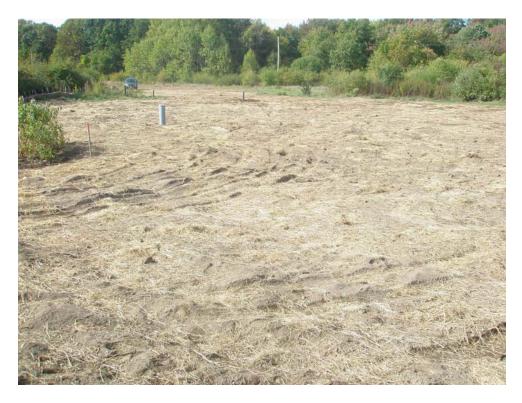
Photograph 3 – Project Area from Southeast

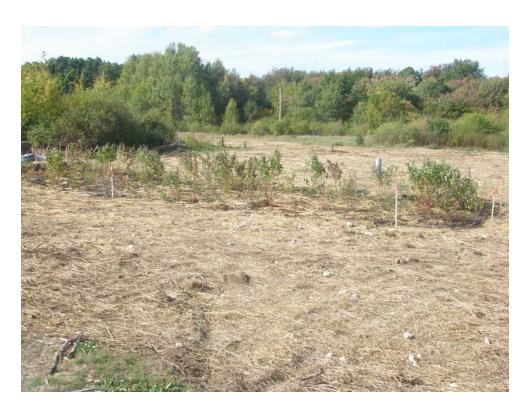
Photograph 4 – Restored Wetland from Southeast
