Re: Inspection Report #1  
25 Through 29 June 2007  
Former Raytheon Facility  
430 Boston Post Road  
DEP File No. 322-647

In accordance with the Order of Conditions for Massachusetts Department of Environmental Protection (Department) File Number 322-647 dated 8 August 2006, Environmental Resources Management (ERM) is pleased to provide the Wayland Conservation Commission (Commission) with this Inspection Report for Northern Area Excavation activities at the Former Raytheon Facility at 430 Boston Post Road in Wayland, Massachusetts (the "Site").

*Appendix A*  
*Site Photographs*

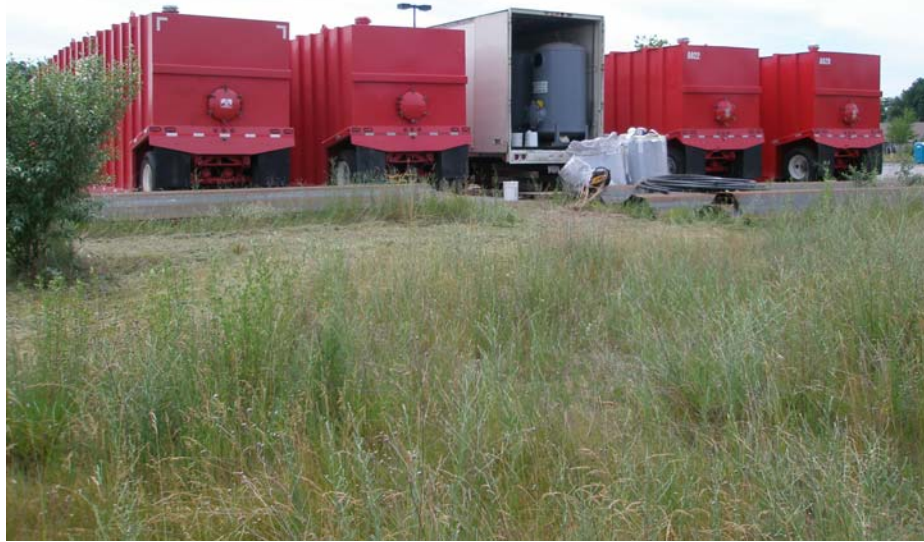
Photograph 1 – Mobile Water Treatment System

Throughout the week several pieces of equipment were delivered to Site including office trailers, the components of the water treatment system (Appendix A, Photograph 1), generators, portable toilets (per Chapter 194 Condition 20), and storage containers. All equipment was set up outside the resource area.

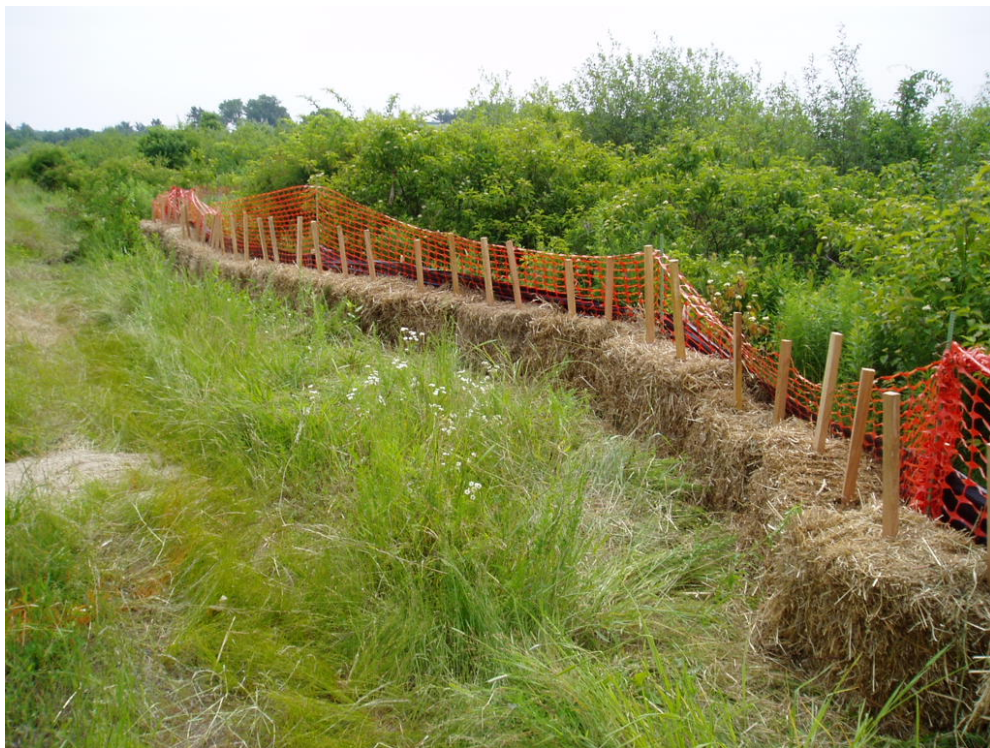
Photograph 2 – Silt Fence with Straw Bales and Construction Fence

Installation of the straw bales (Photographs 2 and 3) and silt sacks (Photograph 4) began on Wednesday, 27 June. The silt sacks were installed (in accordance with WPA Condition 33) in six catch basins in the vicinity of the soil stockpiling area and along the major route of travel between that area and the entrance on Route 20. Site inspections were conducted that morning by an ERM Certified Wetland Scientist (Ann McMenemy) and Professional Engineer (Alicia Kabir). A survey was also conducted on this day to locate the installed silt fence with the purpose of providing a stamped statement from a Professional Land Surveyor attesting to the correct layout of the sedimentation barriers and work within the buffer zone per WPA Condition 27. This certification is provided in Appendix D. (Notes: ERM has extended the straw bales and silt fence to fully encircle the wet pocket area in response to verbal approval from the Commission to relocate the clean-soil staging area outside and to the north of the resource area. The straw bales and silt fence were extended across the bordering wetland nearest to the cofferdam installation and excavation area).

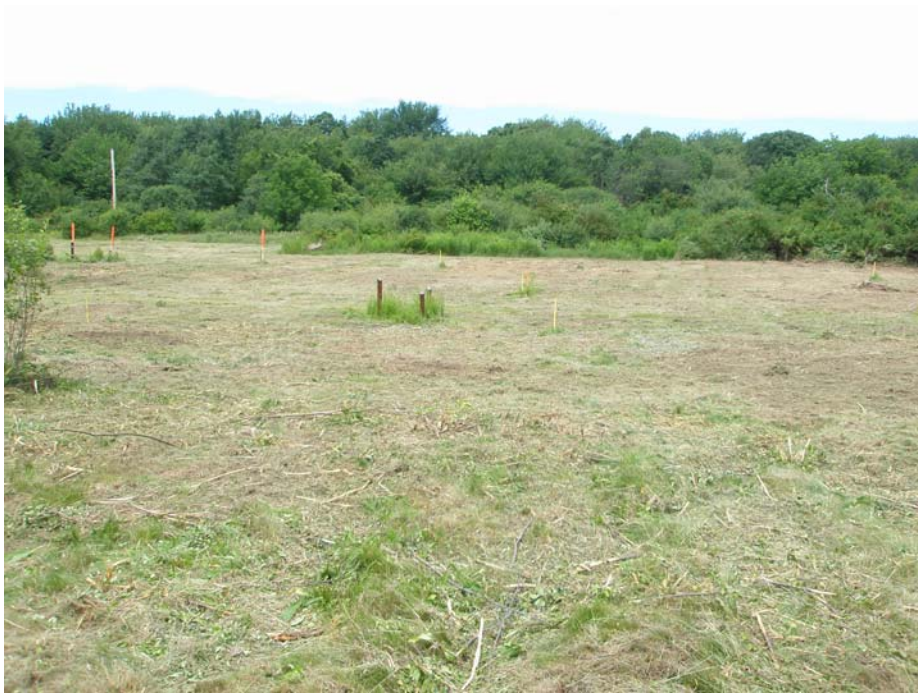
Photograph 5 – Cleared Excavation Footprint Area

Site clearing was completed on Friday, 29 June using a tractor-mounted brush mower (Photographs 5 and 6). Assembly of the water treatment system also began that day.
