Draft Phase II Comprehensive Site Assessment and Draft Phase III Remedial Action Plan

Former Raytheon Wayland Laboratory 430 Boston Post Road, Wayland, Massachusetts

Draft Phase II Comprehensive Site Assessment

Draft Phase III Remedial Action Plan

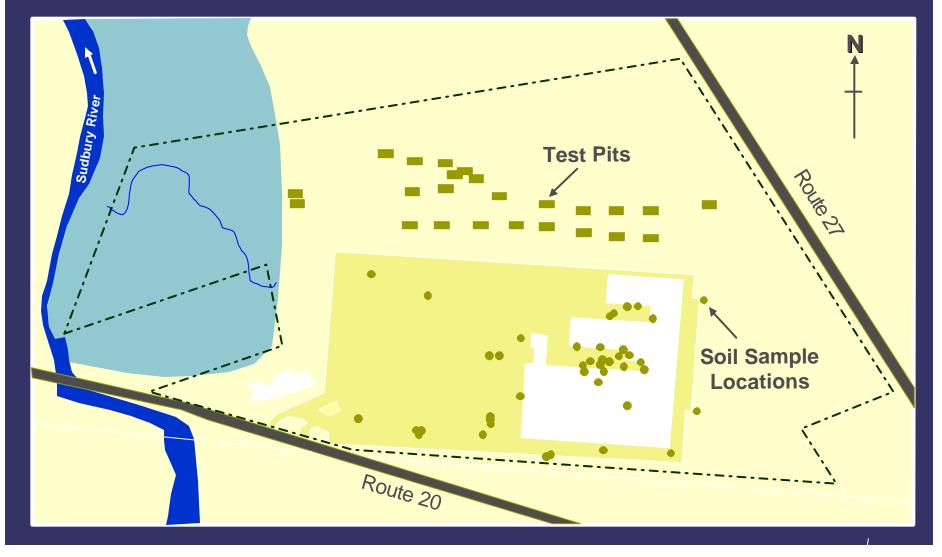
Soil Sampling

- 67 samples analyzed for metals, VOCs, PAHs, and PCBs
- 24 test pits completed in northern portion
- 4 Limited Removal Actions ("LRAs") performed
- Two RAMs performed
 - tank removal and Activity and Use Limitation ("AUL") by new owner, Wayland Business Center ("WBC") RTN 3-13302
 - soil removal at TP-3 for RTN 3-14042
- Soil concentrations are below MCP standards with exception of the restricted areas (Wayland Business Center, Activity and Use Limitation)

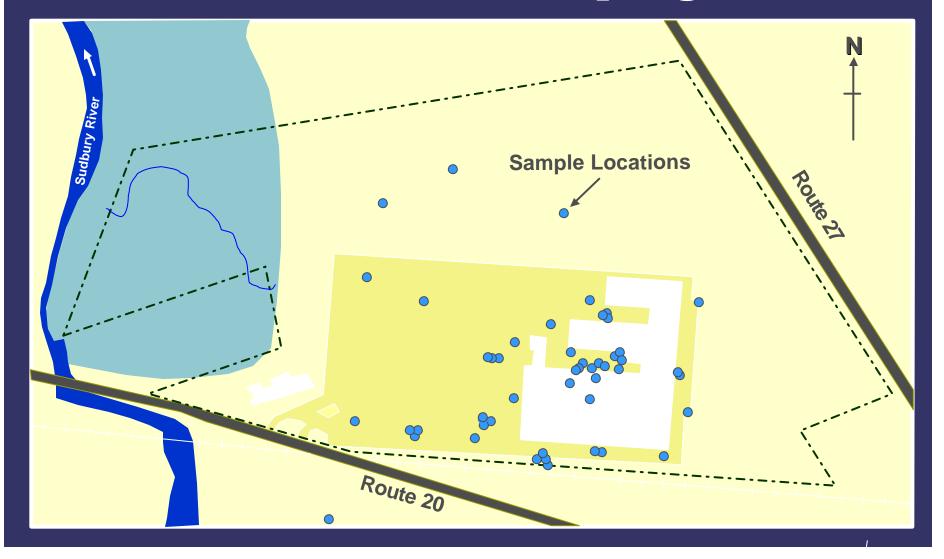
Groundwater Sampling

- Site located in Zone II for Baldwin Pond Wells (1/2 mile) defined by Anderson-Nichols Conceptual Zone II Study
- Groundwater flow in South/Southwest direction
- 58 GW wells installed (shallow, intermediate, deep and bedrock wells)
- Iterative process, 5 phases of drilling
- > 200 analyses of samples since 1996
- Analyzed for VOCs, metals, TPH and inorganic compounds
- VOCs exceed applicable MCP GW-1 guidelines
- Groundwater remediation is required

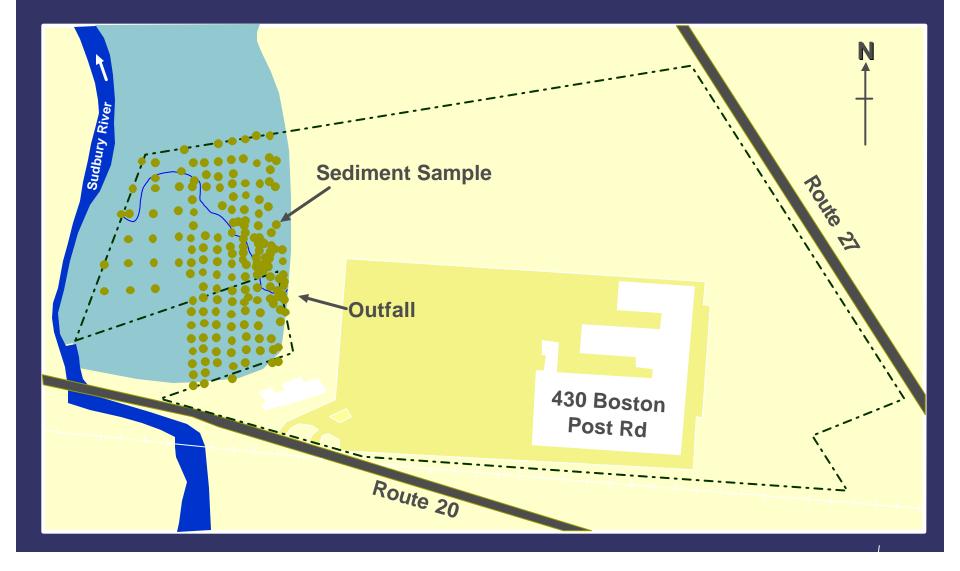
Sediment Sampling

- late 1998 delineated metals, petroleum, and PCBs near outfall
- 1999 completed 2 additional sampling rounds
- 2000 wetland and ecological specialists identified vegetation with stunted growth

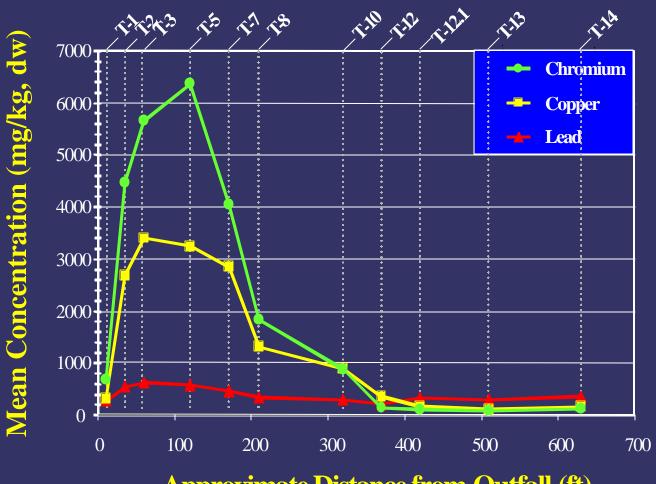
Concentrations of Metals in Wetland Soils

- Majority of impact within 200 ft of Outfall (OF-1)
- Metals, PCBs and PAHs detected in Sediment at depths 0 - 12 inches
- Area of stunted growth coincides with higher concentrations of metals

Approximate Distance from Outfall (ft)

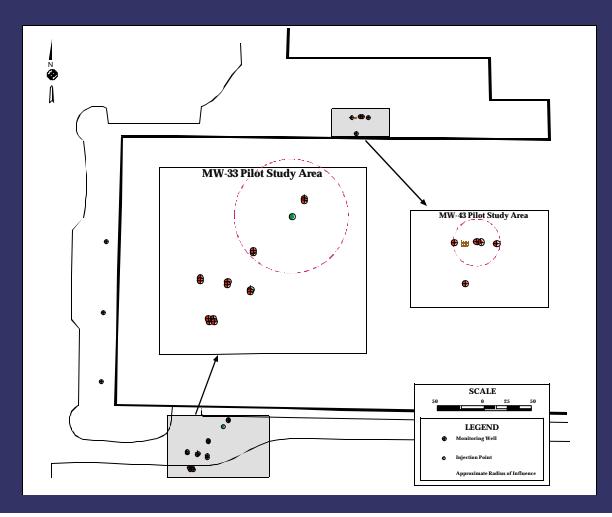
Groundwater Pilot Study Area

- Excavation and off-site disposal of impacted sediments (approximately 1.5 acres)
- Restoration of disturbed wetland area
- Implementation of land use controls
- Groundwater
 - Chemical Oxidation
 - Pilot Study began October 6th

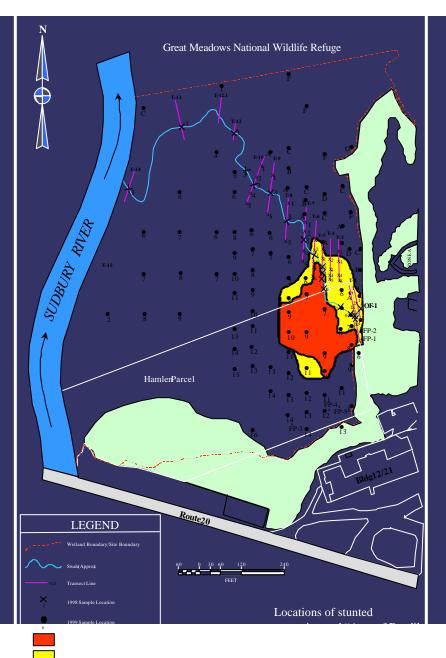
Area of Readily Apparent Harm (ARAH)

Basis of ARAH in draft ERC:

- Stunted vegetation
- Exceedances of Federal and State water quality criteria
- PCBs > 50 mg/kg
- Elevated levels of copper and chromium associated with plant toxicity

- Exposure pathways include surface water, wetland sediments, wetland soils, & biota
- Risk of harm is "readily apparent" in the area of stunted vegetation (see next slide)

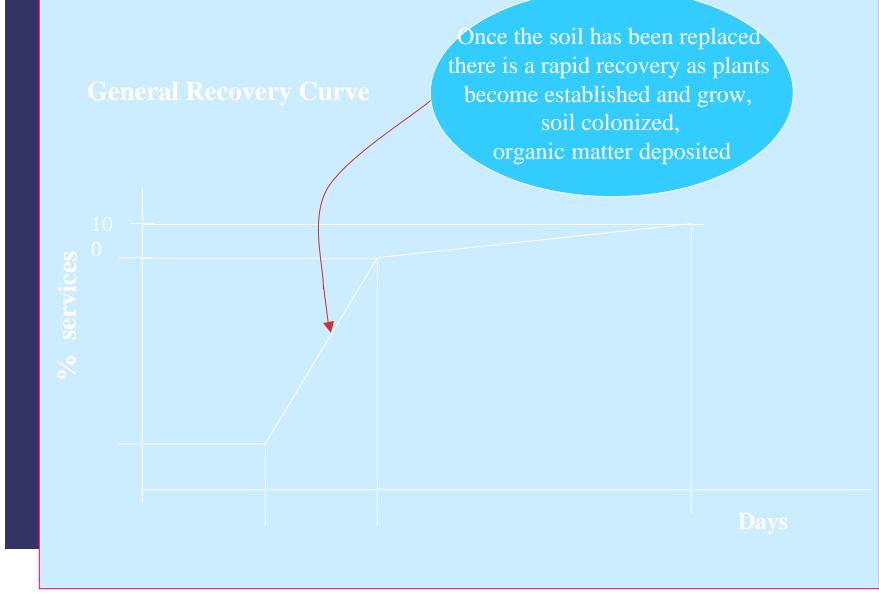
General Recovery Curve

Initial injury due to digging interfering with bird foraging, lack of plant biomass, disturbance from remedial activity

The final tail of the recovery curve represents the full development of soil organic matter and invertebrate community
