# THE WETLAND REMEDIATION SITE AT THE FORMER RAYTHEON FACILITY WAYLAND, MASSACHUSETTS 2005 WETLAND RESTORATION MONITORING REPORT

# December 2005

**Project Name:** 2005 Wetland Restoration Monitoring Report

**Monitoring Report:** Year 2 of 5

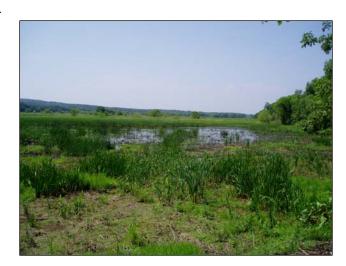
View looking north from the overlook. June 2005.

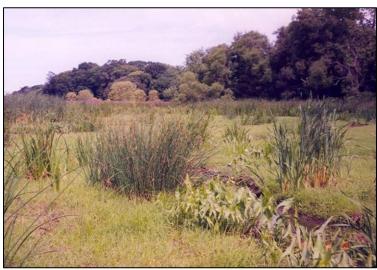
View of the swale at a downstream location (left) and view of the swale near the discharge culvert with soft-stemmed bulrush, bur-reed, pickerelweed (*Pontederia cordata*, OBL), and rice cut-grass (right). August 2005.

As per the Plan, standing water was present in the swale during each monitoring visit, including in August when conditions were the driest of the three site visits. Soft-stemmed bulrush, bur-reed, and nodding bur-marigold were also observed in the swale.

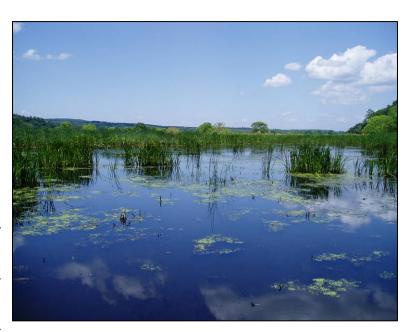
View looking north dominated by open water, greater duckweed (*Spirodela polyrhiza*), and bur-reed as observed during July 2005.

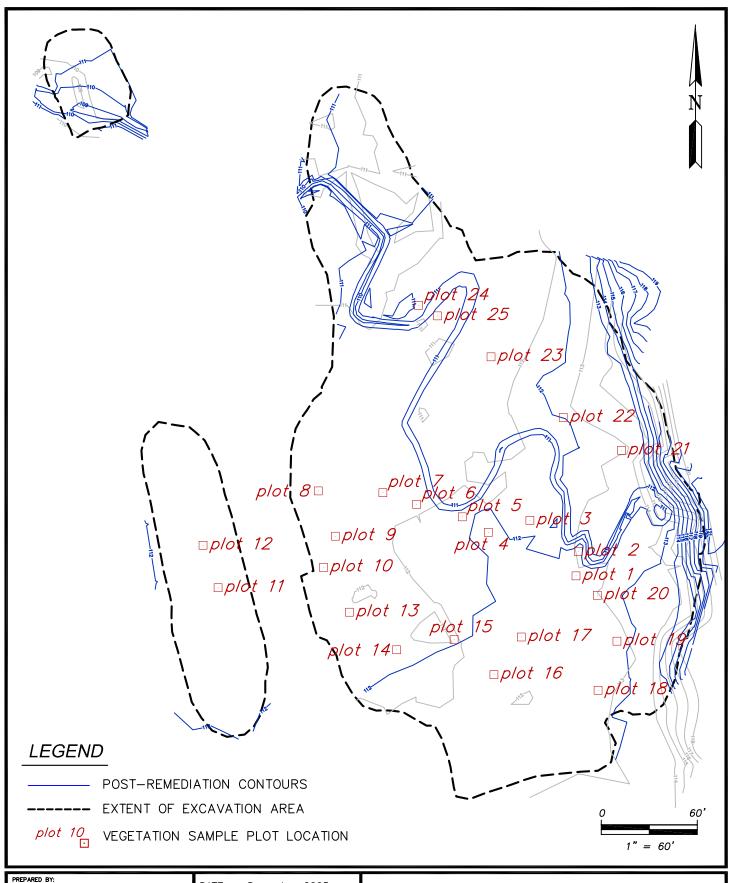
# Exhibit 2

Vegetation was sampled on August 18, 2005, using 25 one-meter<sup>2</sup> plots randomly spaced throughout the remediation project area (Exhibit 2). Data collected in each plot included a list of species present, estimated percent areal cover by species, and percent areal cover of bare ground and water for each plot. The data was tabulated and averaged across plots. Areal cover data can exceed 100 percent, due to overlapping layers of vegetation. For example, tall species will overhang middle and smaller sized plants, creating a multi-layered effect. A meander survey was used to identify plants present in the area but not contained in the sample vegetation plots. Plant taxonomy and nomenclature follows *The Vascular Plants of Massachusetts: A County Checklist* (Sorrie and Somers, 1999).
