2007 Wetland Restoration Monitoring Report

Raytheon Company

Former Raytheon Facility
430 Boston Post Road
Wayland, Massachusetts

13 December 2007

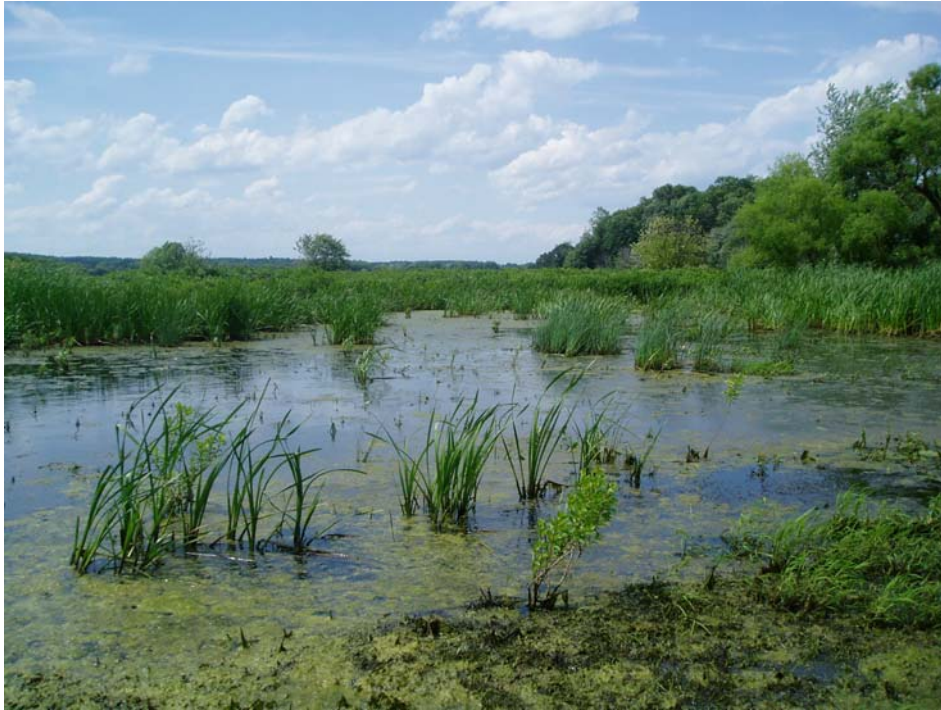
Photograph 1 - Area C looking northwest from base of outfall (7/13/07).
Note flooded conditions.

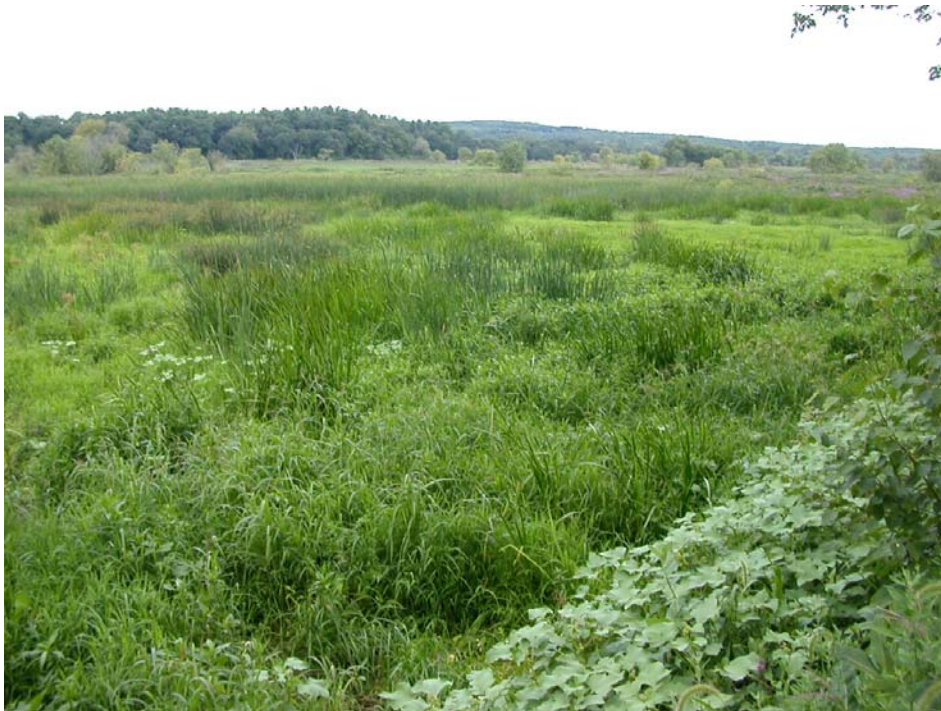
Photograph 2 - Area C looking northwest from above outfall (8/23/07).
Note dense vegetation.

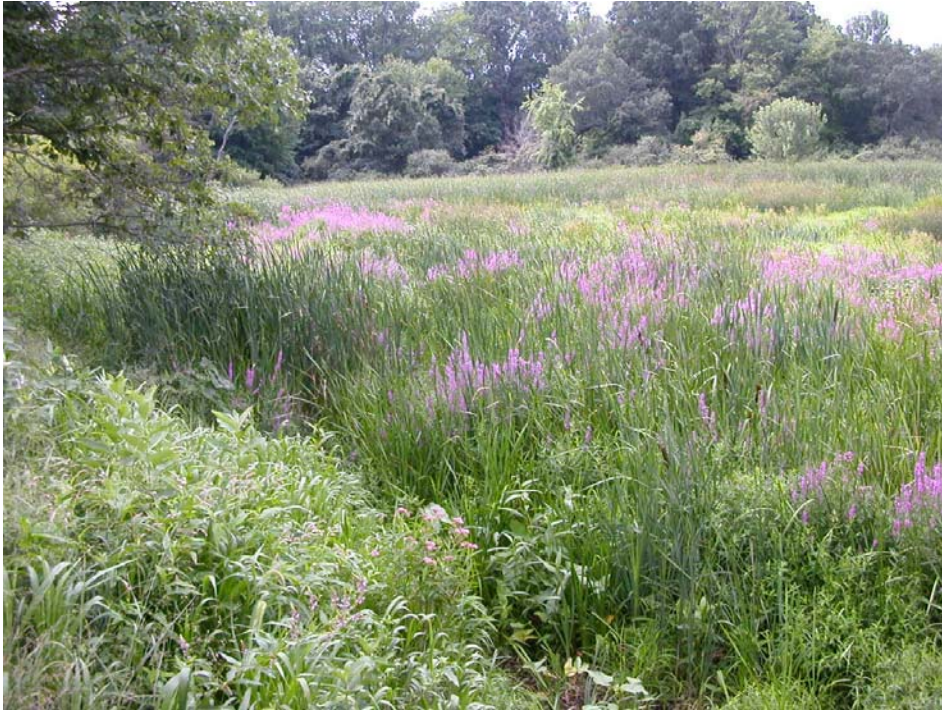
Photograph 3 - Area C looking southwest from above outfall (8/13/07).
Note abundant purple loosestrife.

Based on this mapping, it is estimated that purple loosestrife is a dominant species in the vegetative composition, still covering approximately 25 percent of the remediation area. As in previous years of monitoring, Barnyard grass is also a dominant species in the vegetative composition over approximately 20 percent of the restoration area. Cattail is encroaching into the remediation area from adjacent areas outside of the project area; however, this species is not dominant in any project location. Common reed (*Phragmites australis*) is not present in the remediation area; however, this species is dominant in the wetland to the south of Area C.

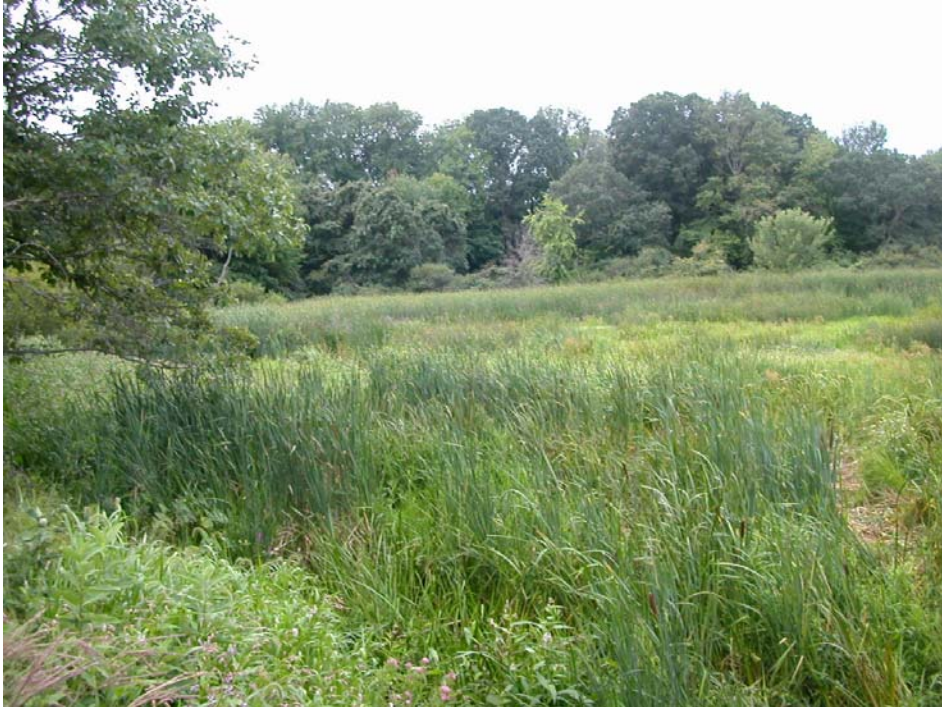
Photograph 4 - Area C looking southwest from above outfall following
invasive species management activities (8/23/07).

Purple loosestrife and barnyard grass seed heads were cut throughout Areas B and C, collected in plastic bags, and then disposed of off-site. No invasive species management was warranted in Area A.

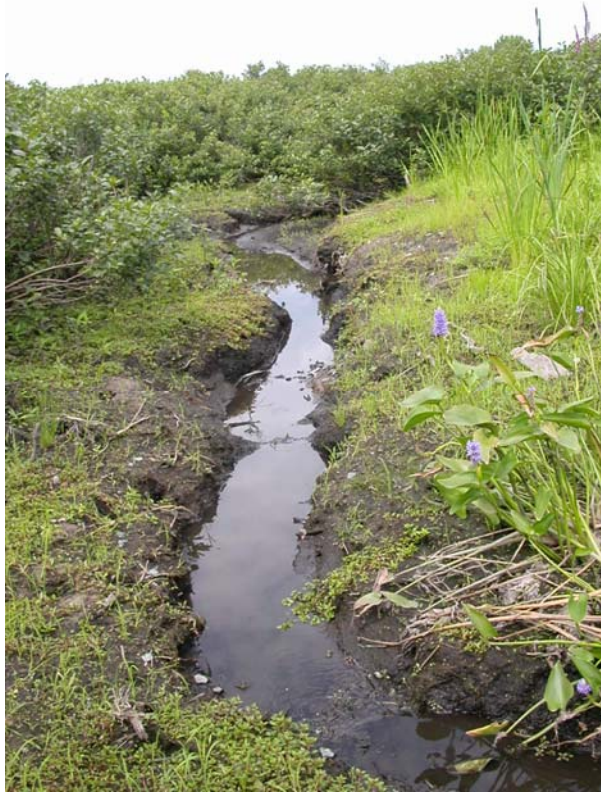
- The stream channel continues to develop and become naturalized. Please refer to photograph 5 (Appendix A);
- Area A is nearly 100% vegetated, unlike during previous monitoring events;

Photograph 5 - Northern end of Area C looking west along stream channel (8/13/07). Note pickerel weed and stream bank development.

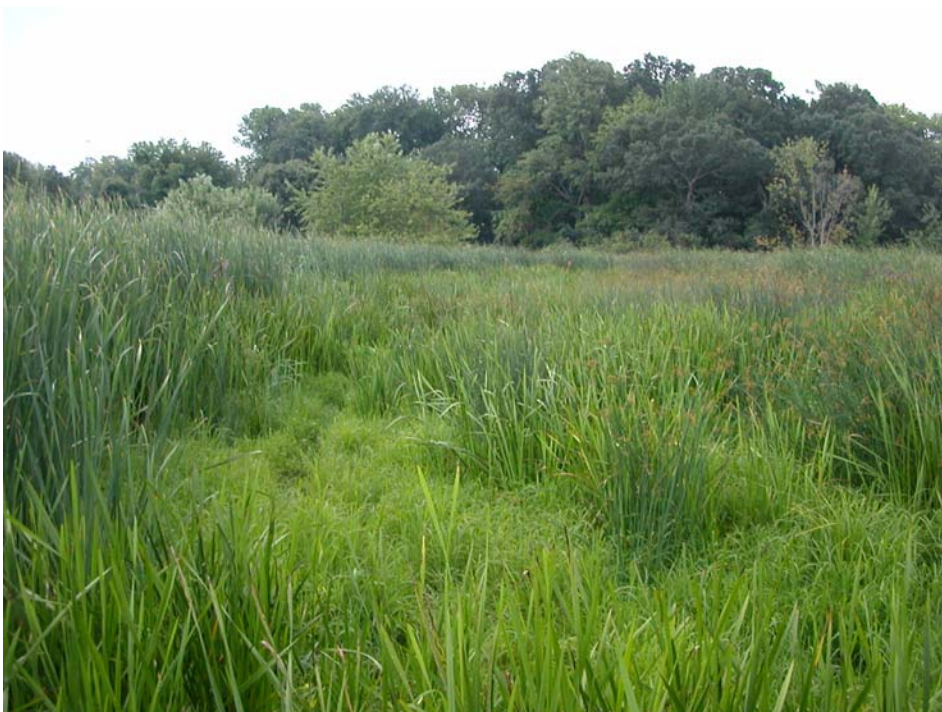
Photograph 6 - Central portion of Area C looking south (8/13/07). Note vegetative diversity.

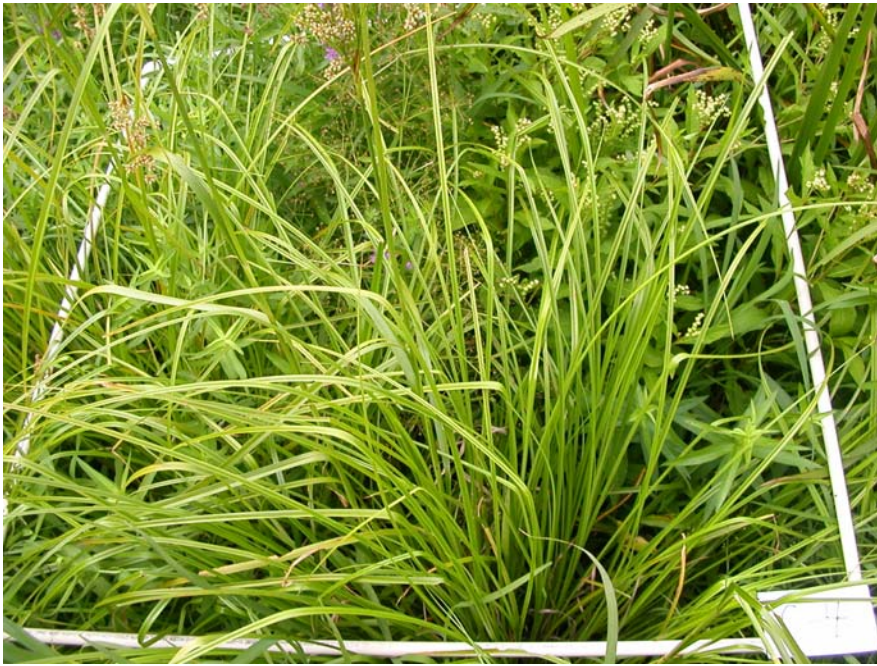
Photograph 9 – Vegetation Plot C-4 (8/23/07). Note vegetative diversity.

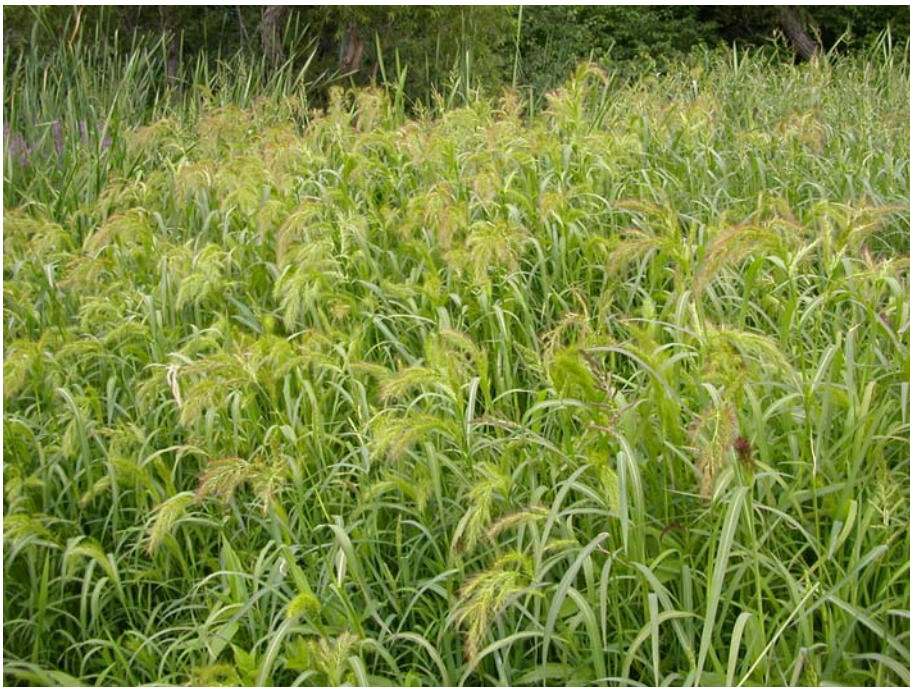
Results of the 2007 invasive species mapping indicate that, while barnyard grass has decreased in density since the 2006 growing season, this species continues to dominate in a large portion of the restoration area. In addition, purple loosestrife is the dominant species across a greater percentage of the restoration area as compared to the 2006 growing season. These results suggest that mechanical control of barnyard grass, an annual species, may be a factor in reducing seedfall and, as a result, reducing its coverage in the continuing development of a perennial wetland plant community. Also barnyard grass is not a hydrophyte, and will likely have difficulty establishing over the long term in the emergent floodplain hydrology of the restoration area. For purple loosestrife, a widespread perennial herb common if not dominant in many areas of the adjacent Sudbury River floodplain, the results suggest that limited mechanical control may not be effective in limiting its competitive success.

Photograph 10 – View of northeast portion of Area C, where barnyard grass still dominates the vegetative cover (8/23/07).

Barnyard grass is a summer annual grass that has a Facultative Upland indicator status, therefore, this species is an invasive, non-wetland plant. As illustrated by the reduction in barnyard grass coverage between the 2006 and 2007 growing seasons, this grass can be controlled over time through early season cutting/mowing. As reported previously, the continued cutting of barnyard grass will likely take years to show progress in portions of the remediation area where it dominates, as viable seeds are already present in the soil in great quantities. The documented success in the restoration of wetland hydrology within the restoration area will also likely play a role in the continuing reduction of coverage by barnyard grass.
