2008 Wetland Restoration Monitoring Report

Raytheon Company

**Former Raytheon Facility
430 Boston Post Road
Wayland, Massachusetts**

USACE Permit No. 200300294
MADEP File No. 322-533
MADEP BWSC Tier 1B Permit No. 133939/RTN 3-13302

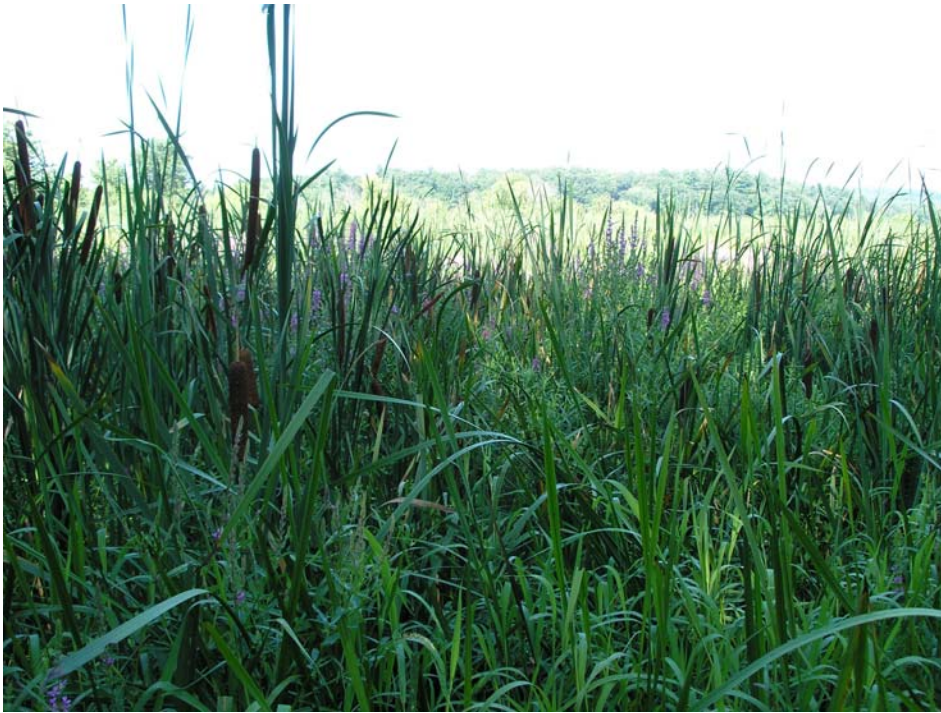
Photograph 1 - Area C looking west from base of outfall (8/1/08).
Conditions were flooded to the base of slope. Note very dense vegetation.

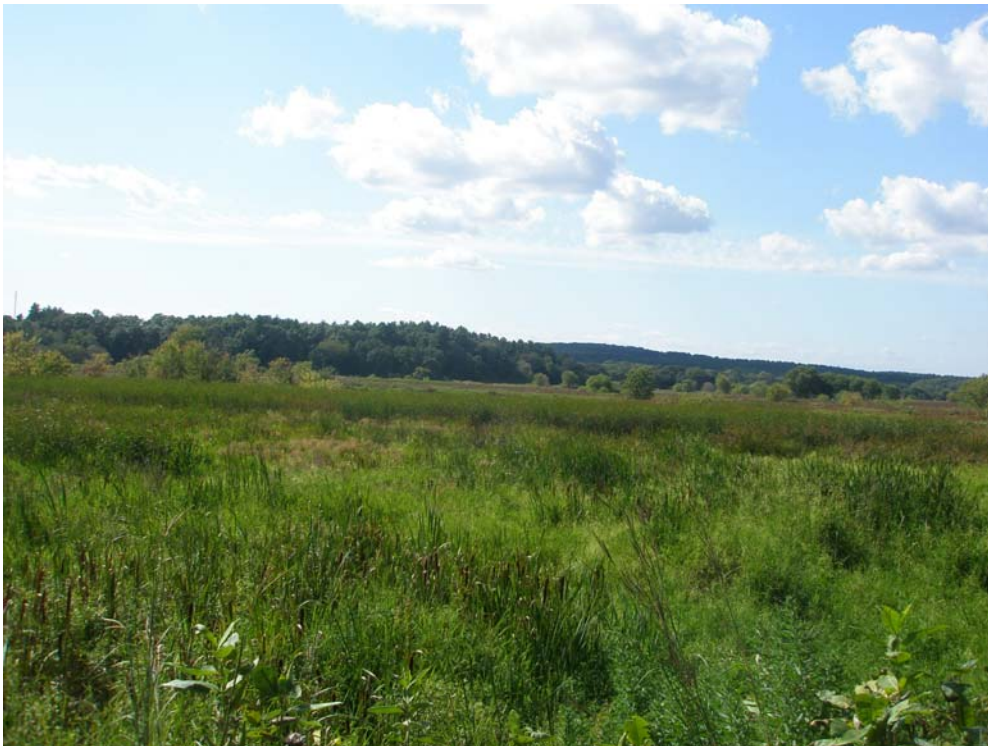
Photograph 2 - Area C looking northwest from above outfall (9/3/08).
Note dense vegetation.

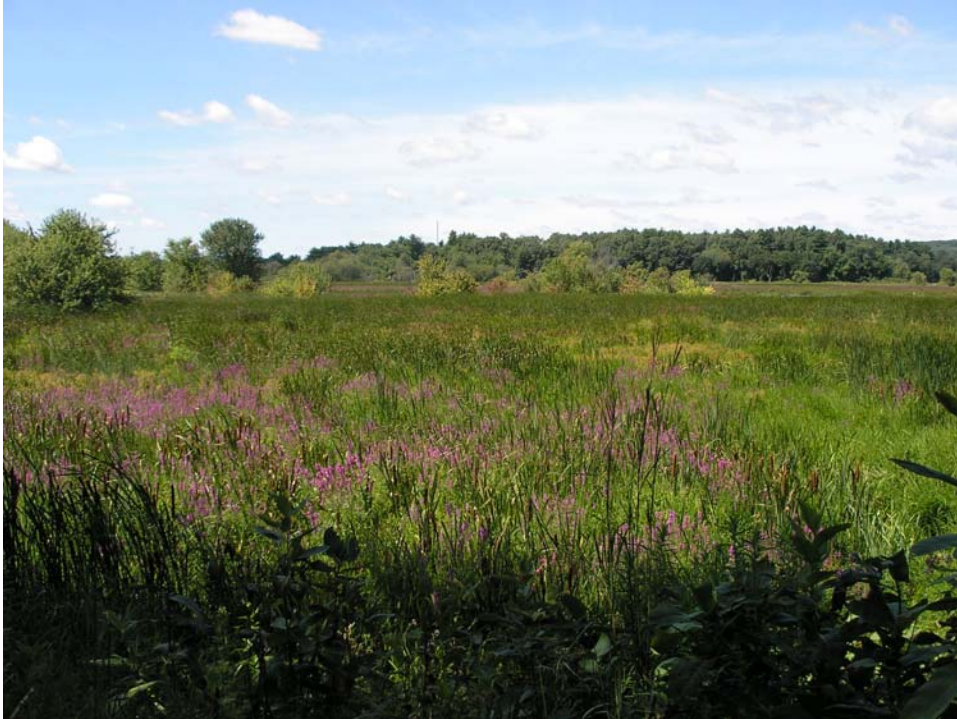
Photograph 3 - Area C looking west from above outfall (8/27/08). Note abundant purple loosestrife.

- Purple loosestrife continues to be a dominant species in portions of the restoration area. A slight reduction in areal coverage of purple loosestrife has been observed since mechanical control efforts began in 2005; however, it is unlikely that mechanical controls will be successful based on the dominance of this species in many areas of the adjacent Sudbury River floodplain;

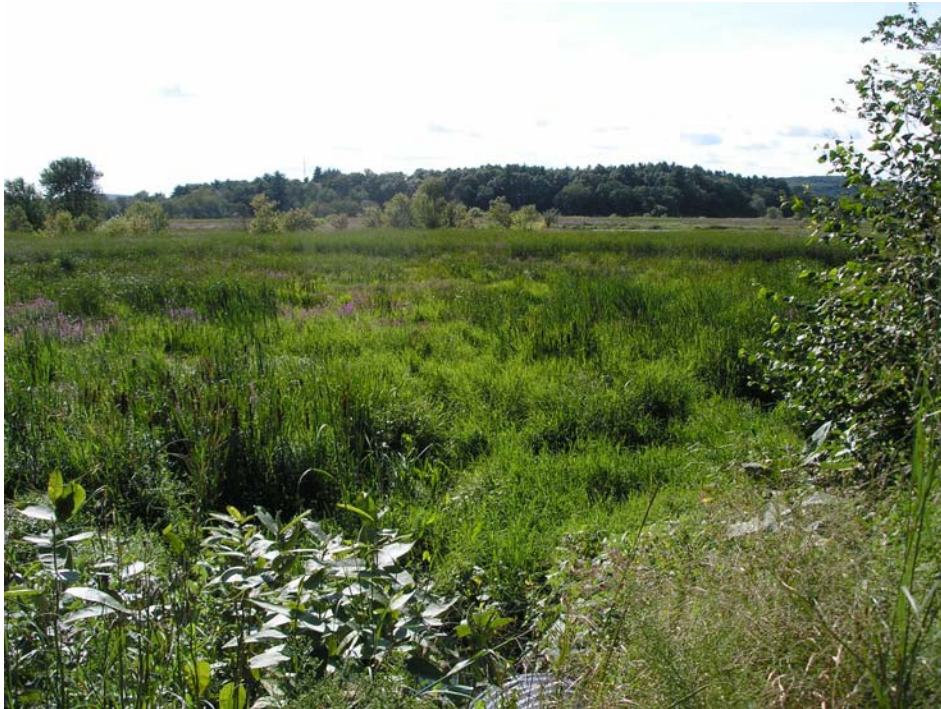
Photograph 4 - Area C looking west from above outfall following invasive species management activities (8/27/08).

ERM conducted invasive species control measures on 27 August 2008 for purple loosestrife. The 2008 invasive species control measures continued the maintenance practices conducted during the 2005, 2006, and 2007 growing seasons.

Purple loosestrife flowers were cut throughout Area C. Seed heads were not present at the time of cutting; therefore, cut plants were left on Site. No invasive species management was warranted in Areas A and B.

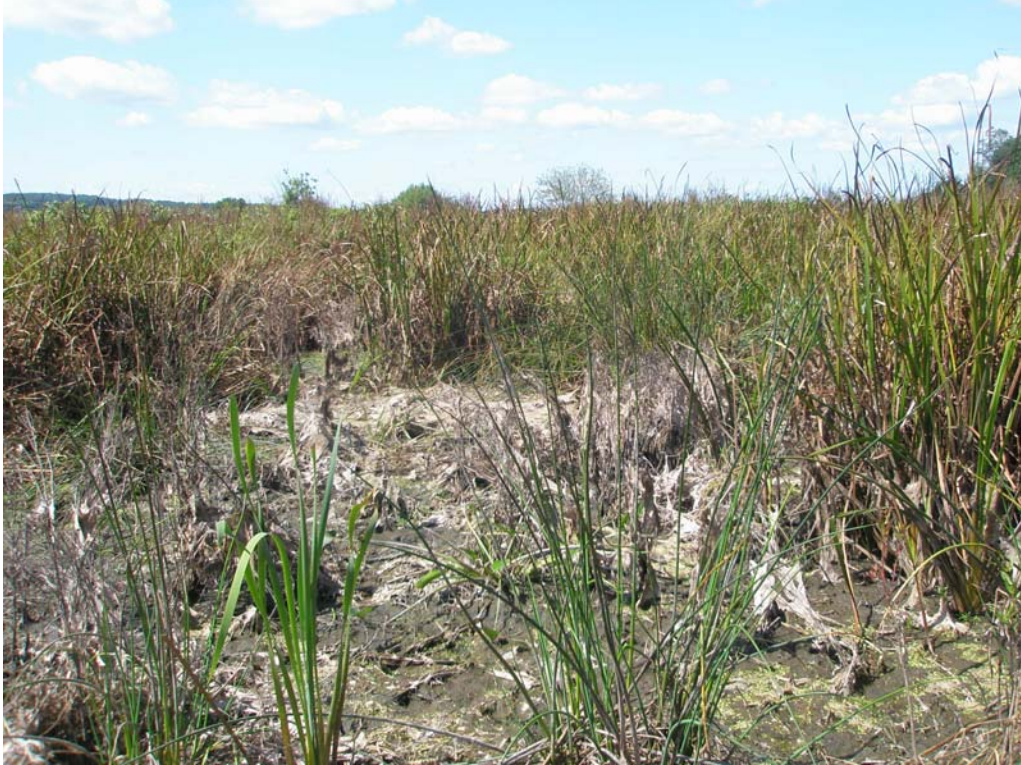
Photograph 5 - Northern end of Area C looking north (9/3/08). Note algal mat on vegetation indicative of high water levels.

Post-remediation topographic elevations were previously surveyed and found to be consistent with the original contours (Woodlot, 2004). Based on field observations, hydrologic conditions range from shallow inundation to surface saturation depending on the location within the remediation project area. In early August 2008, ERM observed a majority of the restoration area inundated with standing water (Appendix A, Photograph 1). Approximately 2 inches of standing water were observed adjacent to the culvert in Area C (Figure 2) with depths rapidly increasing to the north and west. In September 2008, the flood waters of the Sudbury River had receded and surface saturation was observed throughout the restoration area, except for several small areas of standing water and about 4 to 6 inches of flowing water in the stream channel (Figure 2). An algal mat was also observed in the northern end of Area C and throughout Area A, indicating the presence of standing water for a prolonged period of time. Algae was observed at a height of approximately 2 feet on the stalks of plants in the northern portion of Area C.

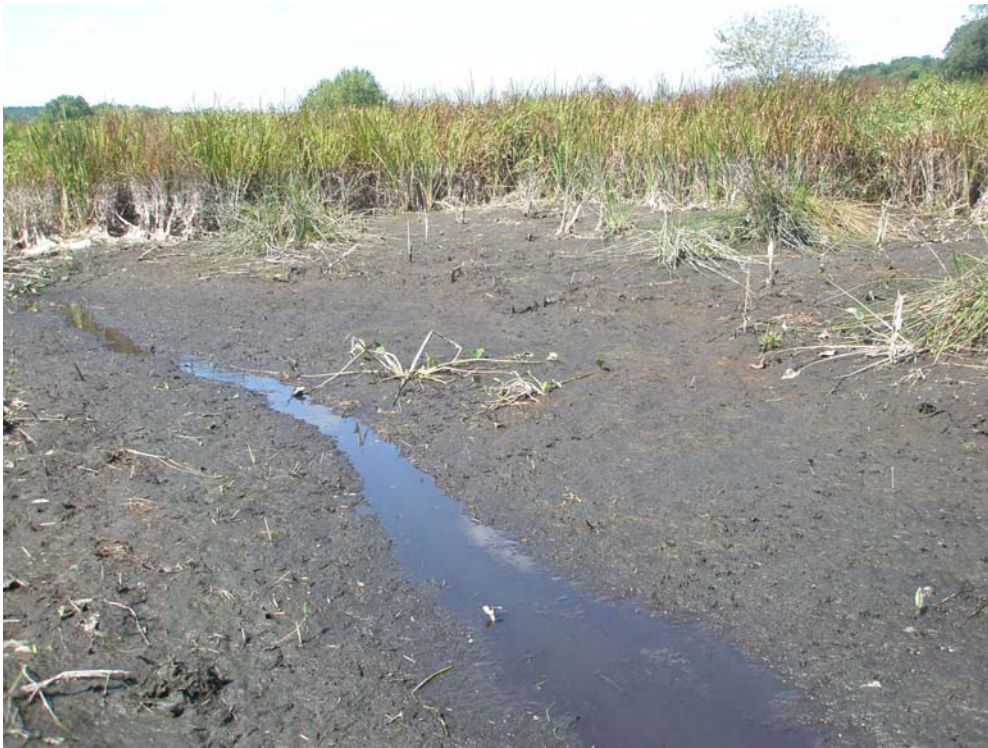
Photograph 6 - Central portion of Area A looking north (9/3/08). Note sparse vegetation as a result of inundation until late in the growing season.

Area A was sparsely vegetated during the 2008 monitoring; however, the lack of vegetation is likely attributable to the prolonged period of standing water in the area and not the result of residual impacts to sediment. In previous years when the floodwaters of the Sudbury River retreated early in the growing season, Area A was observed to be approximately 75 percent vegetated.

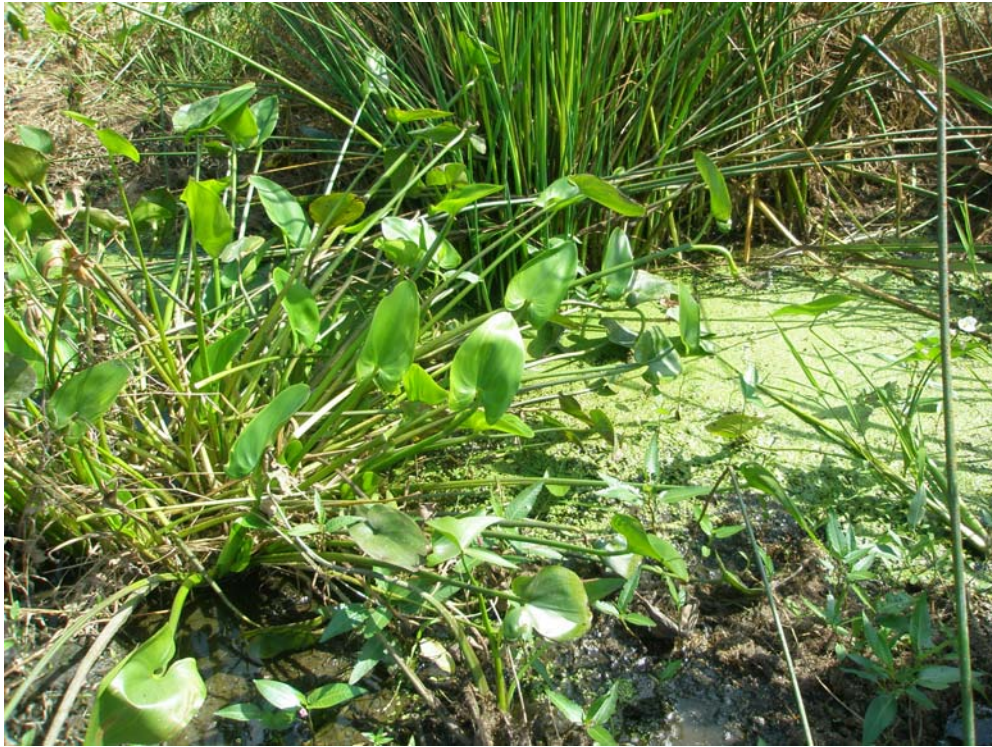
Photograph 7 - Stream channel in Area C. Note duckweed on standing water and diversity of vegetation (9/3/08).

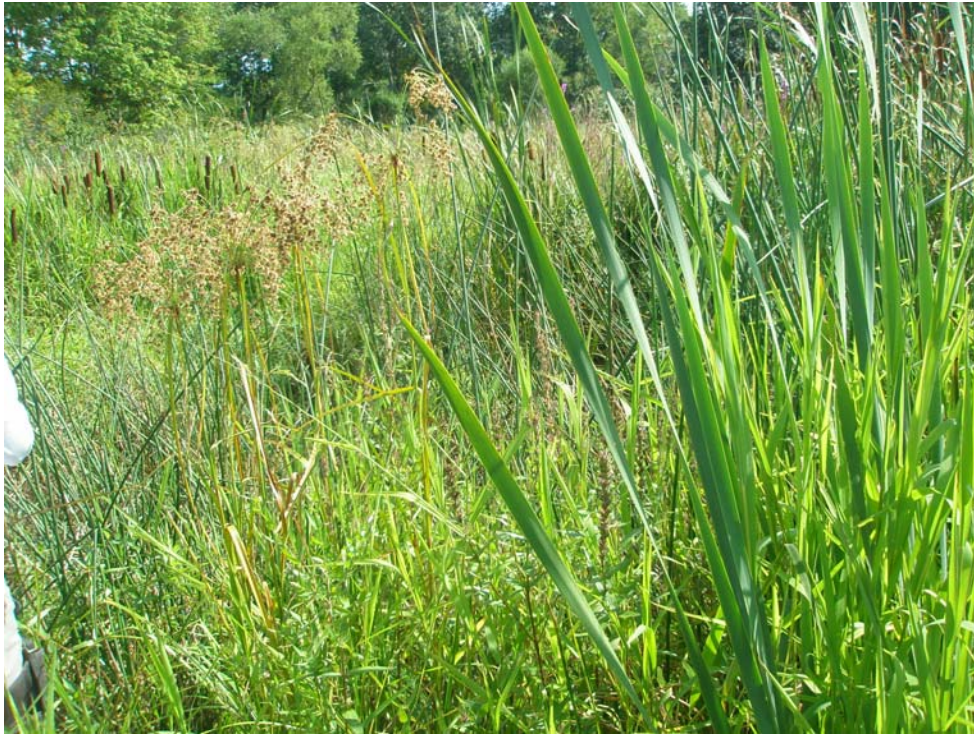
Photograph 9 – Vegetation Plot C-8 (9/3/08). Note vegetative diversity.

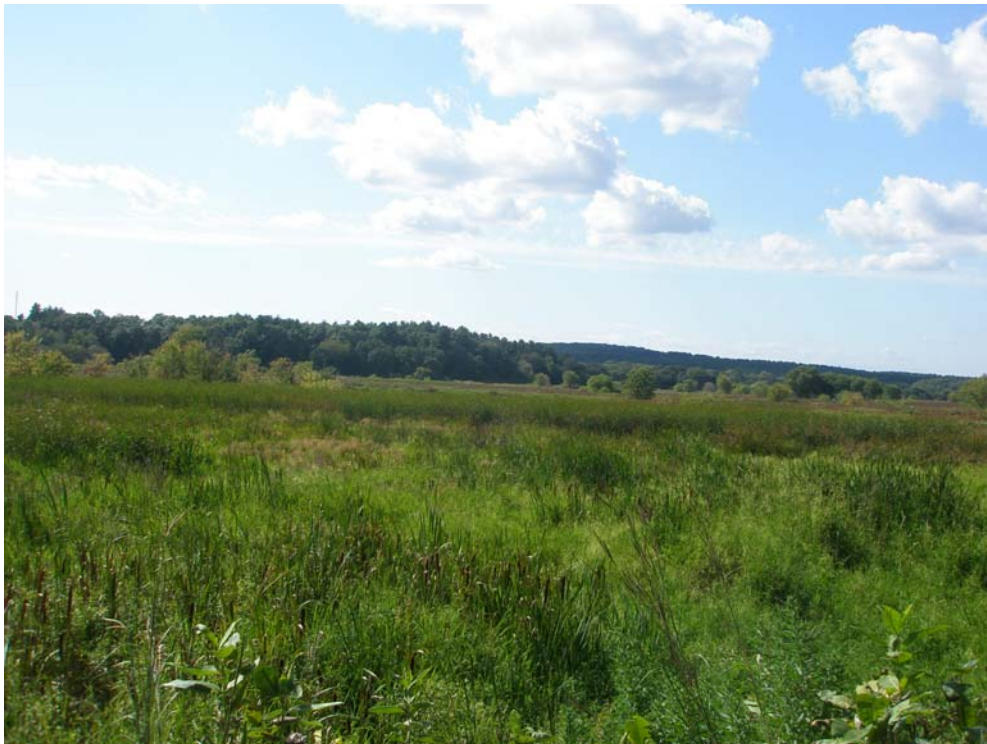
Photograph 10 – View to the northwest from above culvert. Note diversity of vegetation and purple loosestrife along Sudbury River in background (9/3/08).
